PLAIN BEARING DAMAGE

Dr. J. M. Conway-Jones & A. J. Leopard

Presented and published in the proceedings of the Fourth Turbomachinery Symposium, Gas Turbine Laboratories, Texas A&M University, College Station, Texas; October 14, 15, and 16, 1976.

The Glacier Metal Company Limited

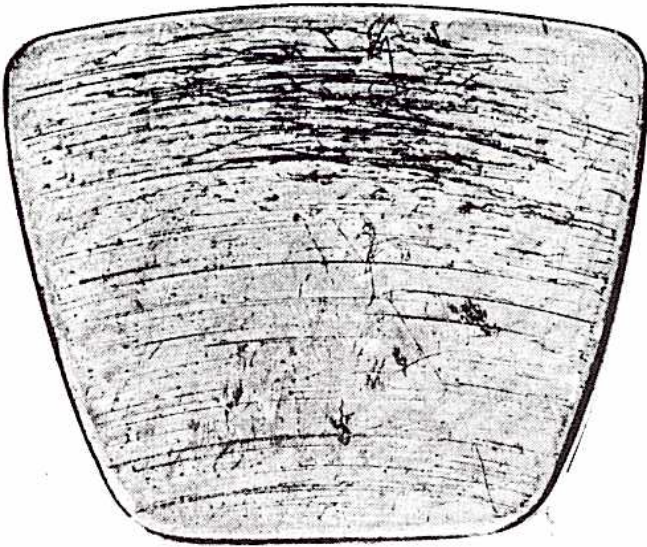
Parallel or circumferential grooves in the bearing surface are normally formed by abrasive particles carried in the circulating oil. Small particles may bounce between the bearing and mating surface, causing a series of intermittent contacts, but larger particles score the soft bearing surface and may eventually become embedded. Fig. 1 illustrates where this has occurred on start up, the particle movement being more irregular than if it had occurred at high speed. It may be concluded in this case that the dirt was present on assembly. Fig. 2 shows a less severe scoring, which has occurred at high speed. A large number of embedded particles are present, and these have been identified as ferrous particles by means of an iron print (Fig. 3). The iron print

Figure 1. Scoring by dirt entering the bearing at start-up.

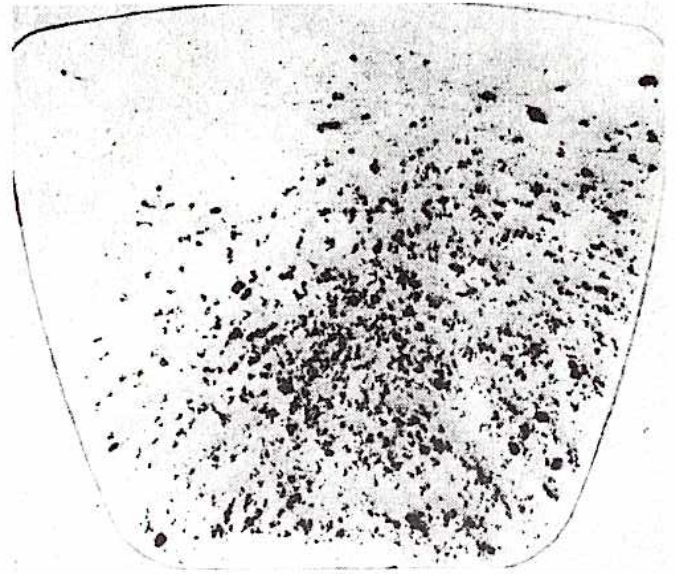
Figure 3. "Iron print" of ferrous particles from pad in Figure 2 (note that print is reversed left-to-right).

is prepared by soaking a piece of filter paper in 1% potassium ferricyanide and sodium chloride solution and placing the filter paper on the bearing surface. Within a few minutes, any iron particles present react to form the characteristic "Prussian Blue" stain and identify the severity of the contamination. In this particular case, the trouble was traced to excessive wear in adjacent reduction gearing. Light scoring can be accepted, providing the roughness caused does not exceed the thickness of the oil film which will generally be of the order of 0.01-0.05 mm (0.0004-0.002 in.). Excessive embedded particles, such as in Fig. 2, can result in scoring of the mating surface, and the bearing should be replaced.

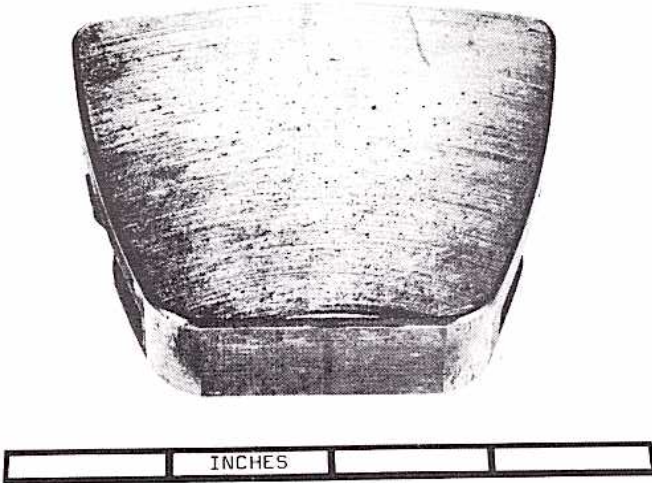
Figure 2. Scoring by embedded particles entering the bearing at high speed.

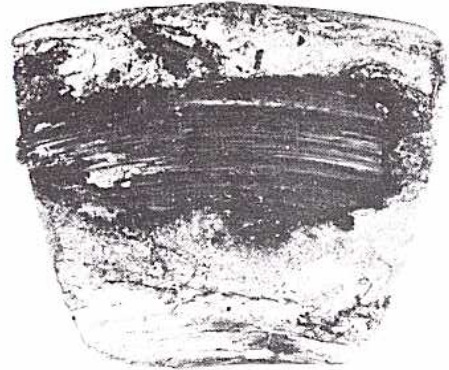
Figure 4. "Black Scab" formation on whitemetal lined thrust pad.

Very severe cases of damage due to embedded particles can occur when the mating shaft is a steel containing chromium. A large particle probably not less than 1 mm (0.040 in.) across is required for the initiation, but upon becoming embedded in the bearing surface, it may form a

hard deposit ("black scab") of material by reaction with the steel journal or thrust collar (Fig. 4). This scab will then cause very severe damage to the mating steel surface which is literally machined away with a formation of characteristic "wire wool." This mechanism is self-propagating when started, and susceptibility to scab formation appears to depend upon the nature of the lubricant and the metallurgical composition of the shaft or collar. Steels containing chromium or manganese in excess of 1% appear to be particularly susceptible to black scab formation, especially in high speed machines with bearing sliding speeds over 20 m/s (65 ft/s) (Ref. 1 and 2). Hard chrome plating of the mating surface has generally been found effective in avoiding this problem, or alternatively a separate sleeve or collar of unalloyed low carbon steel may be used. In addition, particular attention should be paid to cleanliness during assembly, taking care to avoid contamination of bearing surface and oilways with swarf, etc.

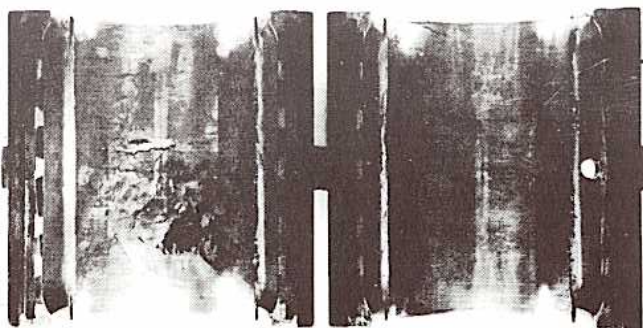
Another problem concerning the use of tight clearances occurs during rapid start up of a cold machine, where heat generated within the oil film may cause the shaft temperature to rise more rapidly than the bearing housing. Differential expansion of the shaft can cause temporary reduction in bearing clearance, which in severe cases may cause metal-to-metal contact in the zones of minimum clearance in profile bore bearings. Fig. 5 shows a typical seizure of a turbine bearing with a "lemon bore" (2 lobe) in which the vertical diametral clearance ratio was 0.0007. The effect is particularly pronounced if the bearing has a massive housing which takes a long time to heat up, or if the shaft is hollow so that it heats more rapidly. As a guide, it is unwise to utilize profile bore bearings with a diametral clearance ratio of less than 0.001, unless it is possible for the machine to be thoroughly warmed before being run at full speed.

Figure 5. Lemon bore bearing seizure on start-up due to inadequate vertical clearance.

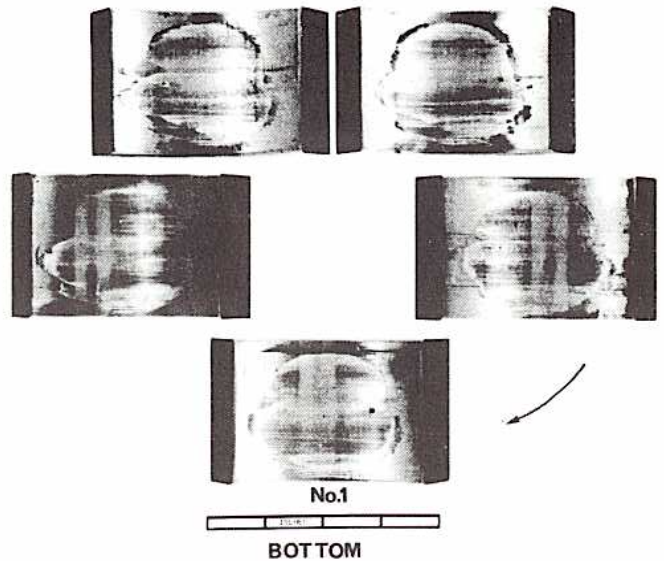
Figure 6. 160 mm (6.3 in.) bore tilting pad journal bearing with minimum diametral clearance across the pivots of 0.160 mm (0.0063 in.) which wiped and seized on rapid start-up to 5,000 rev/min from cold.

For tilting pad journal bearings, the situation is more severe because the heat flow from pad to housing is particularly poor causing the pads to expand inwards at start-up. Fig. 6 illustrates a wipe which occurred in a 160 mm (6.3 in.) bore tilting pad journal bearing under light load which was started from cold to 5,000 rev/min within a period of 2 minutes in a test rig. The bearing had a positive preset, i.e. the pad surface had been bored to a diametral clearance of 0.247 mm (0.0097 in.) but the pad pivots were shimmed to bring the minimum bearing diametral clearance over the pivots of the pads to 0.160 mm (0.0063 in.). Table 1 illustrates that although full speed was reached within 2 minutes, the temperatures continued to rise until after a further 4½ minutes sudden wiping occurred. A pad temperature of 145°C (293°F), although high, would not normally be expected to cause wiping and previous tests had shown that the bearing could operate without damage at temperatures in excess of 160°C (314°F) providing the load or speed was increased slowly. Fig. 7 shows measurements of loss of radial clearance as seen by proximity transducers mounted in the seal housings adjacent to the ends of the pads.

It will be seen that although there was negligible differential thermal expansion for low speed starts, at 4,000 rev/min a peak was reached after 4 minutes following which housing expansion increased the clearance and the bearing operated satisfactorily. From the photograph, Fig. 6, it is clear that the differential expansion was considerably greater near the centre of the pads than at the edges near where the proximity transducers were positioned. Measurements show that the pad thickness at the centre was reduced from 22.000 mm (0.8661 in.) to 21.960 mm (0.8645 in.). Measurements of other pads were all similar. This indicates that at the centre of the pads the differential thermal growth at the time of wiping exceeded the available diametral clearance (0.160 mm = 0.0063 in.) by 0.080 mm (0.0032 in.) giving the total maximum differential expansion of 0.240 mm (0.0095 in.). The shape of the wiped area is typical and indicates that the journal has become barrelled, due to greater temperature at the surface in the centre. It is probable that the pads have also suffered "pin cushion" distortion as a result of the oil cooling effect on their sides and back.

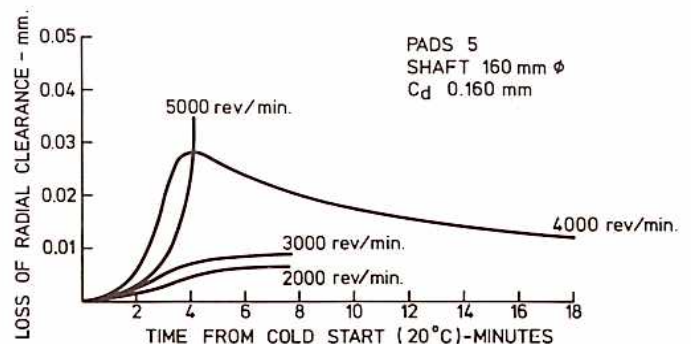
Figure 7. Graph showing loss of radial clearance in tilting pad journal bearing against time from starting, as seen by proximity transducers at the seal housing.

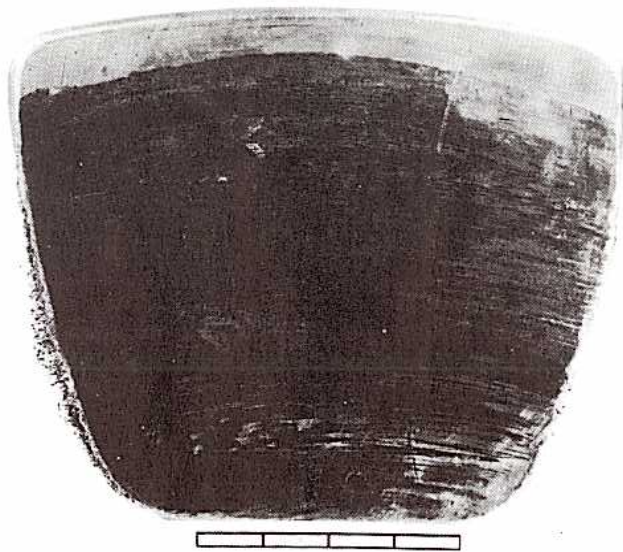
Figure 9. Wiping and lacquering due to heavy load and low speed operation, combined with radial misalignment of collar or pad mounting.

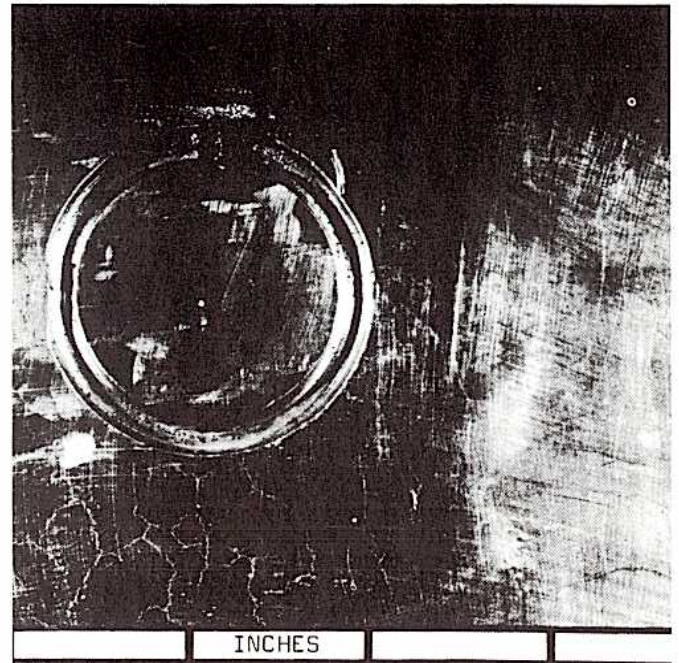
in the centre of the thrust pads to act as a hydrostatic bearing. However, in a recent vertical installation wiping was observed after a few starts and stops (Fig. 10). The extent of the wipe was similar on all the pads in the bearing thus indicating equal pad heights and good alignment of the bearing. Since the wipe occurred over the central areas of the pad where the pad crowning is normally accentuated by the thermal distortion of the pad in operation, it was not clear whether the damage occurred at high speed operation, possibly due to interference with the hydrodynamic oil film by the jacking oil groove, or whether it occurred during stopping as a result of faulty jacking oil supply. Tests conducted in the laboratory with different groove configurations and with ungrooved bearings demonstrated that the minimum oil film thickness at full speed was not significantly affected by the presence or shape of the groove. For example, at a specific load of 1.75 MN/m^2 (250 lbf/in^2) on a 90

Figure 10. Wiping of thrust pad due to loss of hydrostatic jacking pressure during run down.

mm (3.5 in.) pad at 60 m/s (200 ft/sec) the measured minimum oil film thickness was 0.031 mm (0.0012 in.) for an ungrooved pad compared with 0.032 mm (0.0013 in.) for a pad with a circular groove 20 mm (0.8 in.) diameter with no leakage. If the groove was fully vented, which would occur for example in the case of a leak in a jacking oil system, the minimum oil film thickness dropped to 0.019 mm (0.00075 in.) but no damage occurred to the bearing surface. It may be noted that 1.5 liter/min (0.4 US gal/min) oil leakage occurred under these conditions. The test was repeated at twice the specific load over a range of speeds at the lowest of which (10 m/s=33 ft/s) there was still no damage or wiping of the bearing surface; in this case the minimum film thickness was reduced to about 0.007 mm (0.0003 in.). Maximum pad temperature recorded in these tests was 151°C measured within 0.5 mm (0.020 in.) of the surface of the whitemetal.

A series of tests was then conducted with stops under load, first with the jacking oil groove inlet closed and subsequently with it vented. The rig was operated with a given pad specific load at 40 m/s (130 ft/sec) for about half an hour to establish stable thermal crowning. The drive motor power was switched off and the collar allowed to come to rest. The stopping time varied between 35 and 25 seconds depending on the load. There were no surface marks when stopping with loads up to 4 MN/m^2 (600 lbf/in^2), but at 5 MN/m^2 (750 lbf/in^2) a slight polishing was visible over the trailing half of the pad. The polishing extended over the whole pad width and was not confined to the central area. In the polished area, there were marks which appeared to be a replica of the grinding marks from the mating collar, indicating slight softening of the surface of the whitemetal as the collar came to rest. When the tests were repeated with unrestricted leakage from the jacking groove, there was no damage when stopping under specific loads up to 2 MN/m^2 (300 lbf/in^2) but after stopping with a load of 3 MN/m^2 (450 lbf/in^2) a slight wipe occurred in the centre of the pad very

similar to that encountered on the original installation. Although assurances had been given that the high pressure oil system in the original installation was in order, eventually a fault was found in it and rectified.

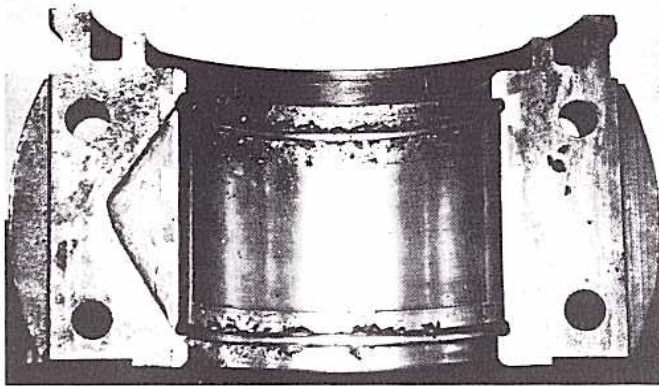
Figure 11. Fatigue on the lands in the chambered top of a turbine bearing.

The fatigue strength of whitemetal decreases markedly with increased temperature (Ref. 3) so that a partial loss of oil supply pressure may result in over-heating and produce fatigue damage in a machine which is only moderately out of balance. This is particularly so if there are narrow lands adjacent to oil grooves or in the "chambered" top half of a turbine bearing (Fig. 11), these areas having reduced load carrying capacity for out of balance forces. Fig. 12 illustrates two pairs of journal pads from the top and bottom of 5-pad bearings from a high speed vertical turbo feed pump which had lost blades in service. Four of the five upper pads were cracked (top, right) and it will be noted that the whitemetal has lifted slightly adjacent to the cracks presumably due to high pressure pulses of oil acting in the cracks. The irregular outline of the polishing is typical of fatigue. The fact that one pad is not cracked (top, left) is also typical of statistical scatter of fatigue damage. In contrast all 5 of the lower pads exhibited a roughly oval area of hard rubbing. This may be compared with Figs. 5 and 6 suggests that the bearing had inadequate clearance to accommodate differential shaft expansion on start up from cold.

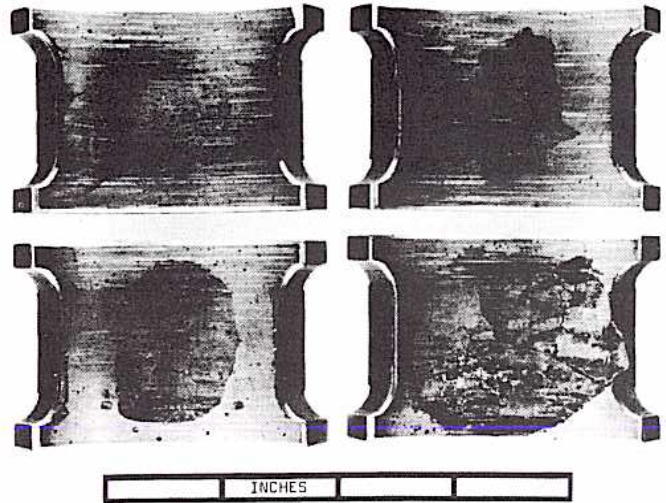
Figure 12. Bearings from a high speed turbo pump which lost blades in service. Top: 4 of the five pads exhibited typical fatigue damage. Bottom: All 5 pads exhibited high temperature rub probably due to inadequate clearance on start-up (Ref. Fig. 6).

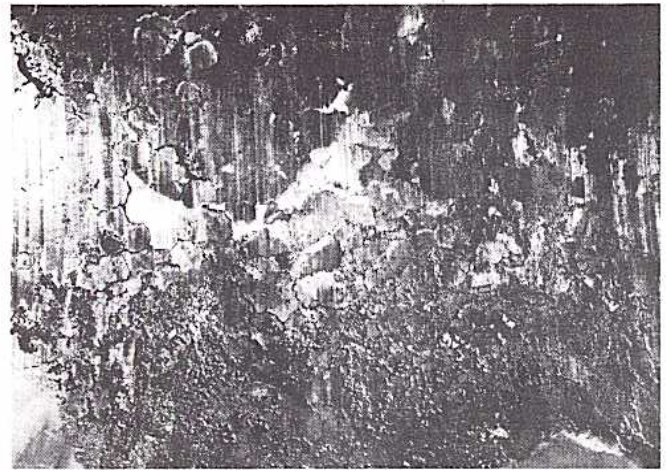
Figure 13. Intergranular craze cracking on whitemetal due to overheating and partial seizure.

The cracking in the lower left bearing is typical of the intergranular craze cracking which is seen more commonly than fatigue in turbomachinery, and may be the result of only a short period of overheating. A typical example in a large steam turbine is shown in Fig. 13. The high temperature zone extends lower than the surface layer of a single wipe, so that more of the whitemetal is weakened. Frictional forces on the surface from contact with the shaft may cause partial shearing of the whitemetal, opening up the cracks, and whitemetal may be displaced into oil grooves or over the edges of the bearing (Fig. 12 lower right). It is often found that fine pores or pits also form in the whitemetal and the lining has a crumbly appearance as can also be seen in Fig. 13. This type of damage often extends only about half way through the thickness of the lining, presumably because the lower layer has more strength, being cooled from the backing. The cause of the overheating may be partial loss of oil supply as in Fig. 13 or excessive overload, as in Fig. 14 which shows the damage caused to a

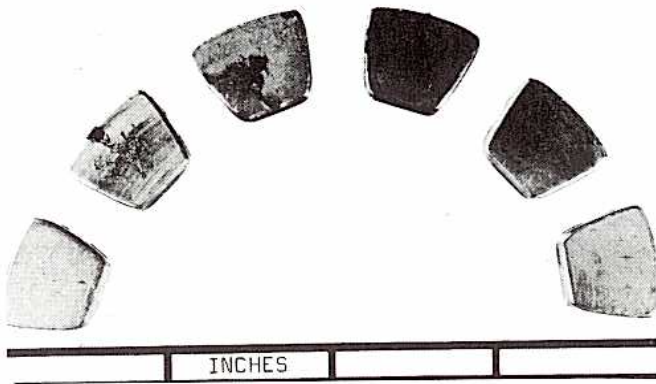
Figure 14. Overload on small steam turbo-generator thrust bearing due to water passing through the turbine.

small steam turbo generator thrust bearing when water passed through the turbine. The fact that there was excessive overload, in excess of 7 MN/m^2 ($1,000 \text{ lbf/in}^2$), was confirmed by the size of indentations of the pad pivots in the carrier ring. In this case, the damage was accentuated by misalignment between shaft and housing resulting in 3 out of 11 pads being subjected to the major part of the load. This type of craze cracking is also seen in cases of overheating and overload as a result of loss of clearance due to differential thermal expansion of the shaft on start up. Another case, presumed to be due to the same mechanism, is illustrated by the fine cracks which were observed on the large pads of Fig. 10 after only two or three starts and stops.

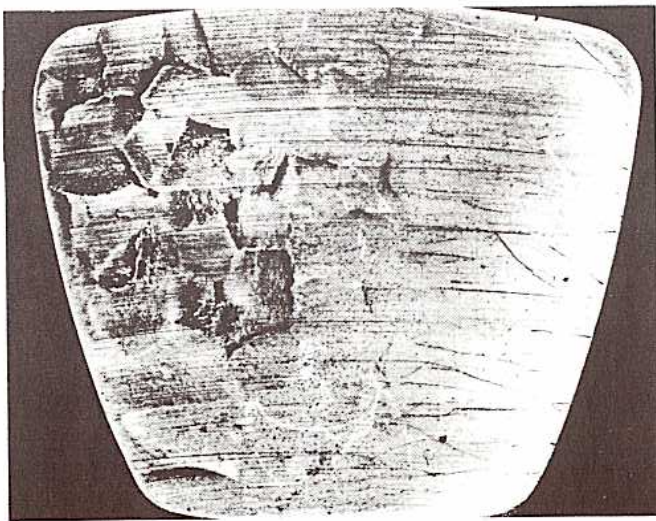
Intergranular cracks may be formed by a thermal ratcheting process described by Boss & Honeycomb (Ref. 4). Tin crystals are anisotropic, having different co-efficients of thermal expansion in each crystal axis. Repeated thermal cycling results in faceting of the bearing surface (Fig. 15) which in severe cases may cause undulations in excess of 0.025 mm (0.001 in.).

After as few as 100 thermal cycles through 100°C (212°F) cracks may form in tin based whitemetal, and whilst

Figure 15. Faceting on a tin based whitemetal pad due to thermal cycling.

undesirable, the authors' experience is that although the crack extends from the surface to the bond, it does not propagate further and the authors have never seen whitemetal particles break away through thermal cycling. Nevertheless, it is an indication of high bearing temperature and steps should be taken to reduce it by one or more of the methods indicated in Ref. 5. Alternatively, a bearing material can be chosen with the ability to withstand higher temperatures such as 40% tin aluminum (Ref. 3).

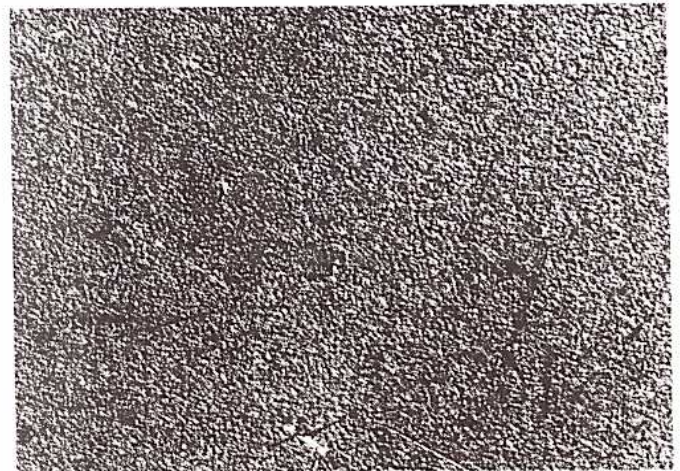
Attention has already been drawn to one form of pitting (Figs. 13 and 14). This is generally uneven, and associated with cracking and results from overheating and overload. Fig. 16 shows a much more regular pitting (in this case magnified $\times 25$), the details of which may be sometimes seen with the naked eye. Fig. 17 shows a general view of the tilting pad and it will be seen that there is a clear boundary between the pitted (matt) central zone and the unaffected zone on the left. The whitemetal has been tapered down by the pitting so that the underlying steel has been exposed near the right hand edge. The cause of the pitting was traced to the discharge of electric current through the oil film resulting in spark erosion. The pits formed are generally hemispherical, uniformly distributed over the zone of

Figure 16. Electrical discharge erosion on thrust pad ($\times 25$).

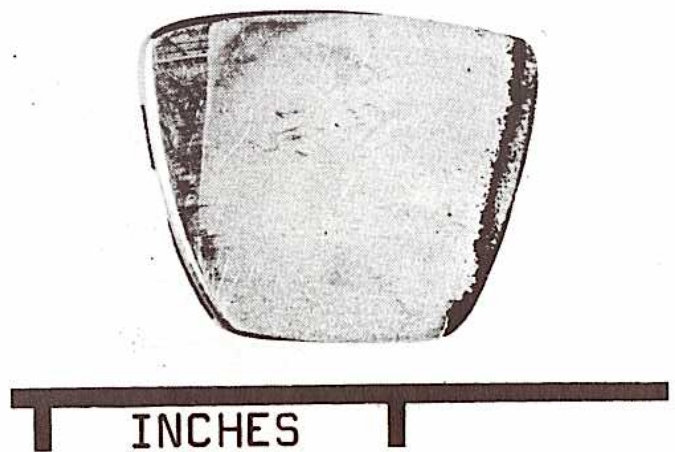
Figure 17. Electrical discharge erosion on thrust pad.

thin film, and may also be found in the mating surface. The various causes such as stray currents from alternators and inadequate earthing have been described in Ref. 6. A contrasting type of pitting is shown in Fig. 18. Instead of being clean and shining the pits have a black deposit. This is tin oxide formed by the fretting of dry bearings in a machine which is not operating, but subject to external vibration from adjacent machinery. This type of damage is particularly likely to happen in marine applications and generally occurs in the crown of the bottom half bearing. In this case the bearing had not been run subsequent to the fretting, and diagnosis was straightforward. Had the machine been operated, wiping of the roughened surface would have occurred, obscuring the pits and possibly removing the majority of the black deposit.

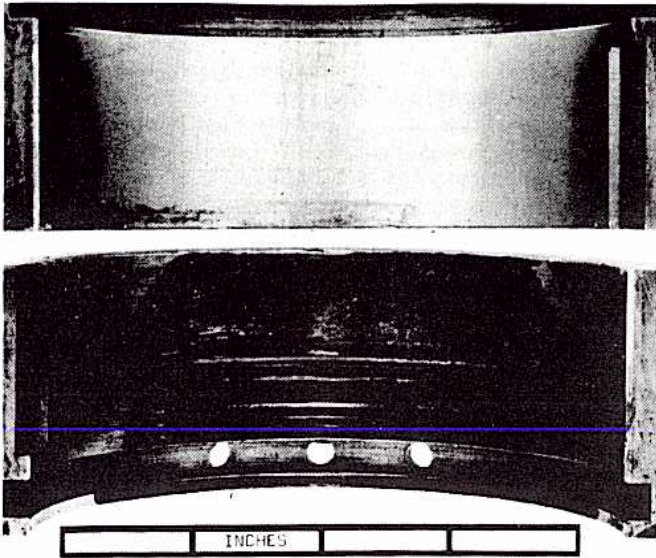
Figure 18. Static fretting damage due to external vibrations.

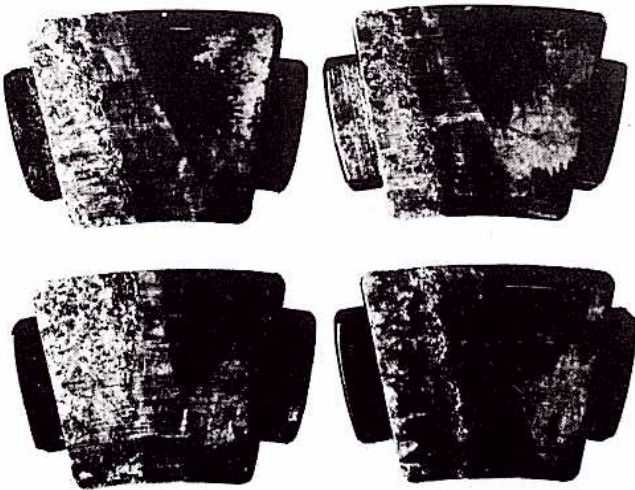
Corrosion can also cause pitting although this is not common with tin based whitemetal. Black tin oxide can be produced by excessive water contamination (in excess of 1%), particularly if chlorides are present as in sea water (Fig. 19). The pits formed are uneven and, in the case of

Figure 19. Tin oxide corrosion of tin based whitemetal pads.

flaking tin oxide, relatively large. When tin oxide corrosion occurs large areas of the whitemetal are affected and, if water is present, it is generally accompanied by rusting of exposed steel surfaces.

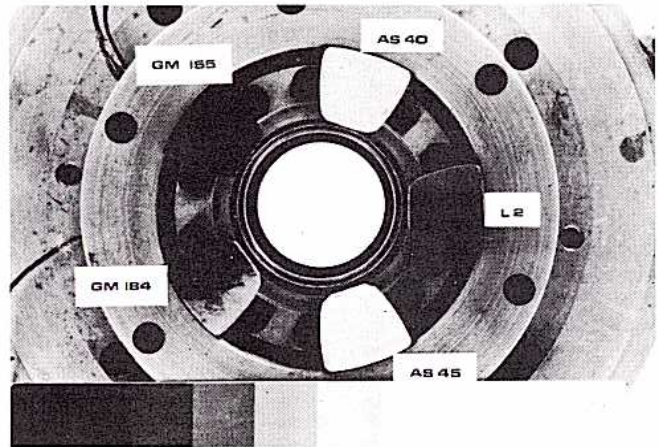
An unusual type of corrosion has recently been seen in marine gas turbines and associated gearing (Ref. 7) fed from a common oil supply. Characteristically the corrosion occurs near the trailing edge of each pad, in the zone of thinnest film and highest temperature. Laboratory investigation has shown that samples immersed in a beaker test with used oil are not affected, but in the 124 mm (5 in.) thrust bearing test rig described in Ref. 8 corrosion and blackening occurred after 40 hours at bearing metal temperatures as low as 110°C (230°F) with a mean collar speed of 78 m/s (250 ft/sec). The oil contains EP additives, and while investigations are not yet complete it appears that the additives may have some influence on the type of corrosion taking place and the phenomenon is also associated with the high rates of shear. A rig test at 130°C (266°F) with a mixed set of pads, including a lead based whitemetal and 40% tin aluminum, showed that after 80 hours the lead based whitemetal was more severely attacked than the tin based whitemetal; the 40% tin aluminum was not affected, however. (Fig. 20).

Figure 20. Corrosion of lead (GM 155) and tin (L 2 and HC 2) whitemetal in gearing oil, with no attack on 40% tin-aluminum (AS 45 and AS 40).

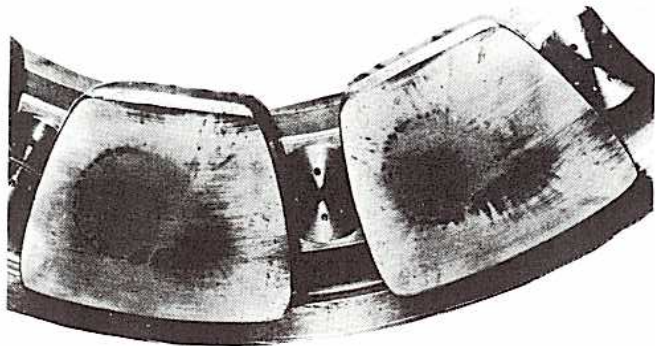
From time to time types of damage occur which do not fall readily into the above categories. One such case was observed recently and is illustrated in Fig. 21. This shows part of a tilting pad thrust bearing which operates at a speed of 70 m/s (230 ft/sec) in which the pads experienced high whitemetal temperature, 170°C (340°F) as measured by thermocouples mounted 0.5 mm (0.020 in.) below the pad surface.

Adequate oil film thickness had been maintained and there was no wiping of the whitemetal but due to the high temperature, excessive crowning of the pad occurred. The whitemetal in the area of the crown under the combined effect of high pressure and temperature was deformed to form a hollow 0.007 mm (0.0003 in.) below the original pad surface surrounded by a rim 0.010 mm (0.0004 in.) above the original surface. When the pad cooled the rim was

Figure 21. Thrust pad subjected to excessive temperature causing deformation of whitemetal without wiping.

exposed and polished (showing dark in Fig. 21 due to the lighting) presumably during subsequent starts and stops under light load.
